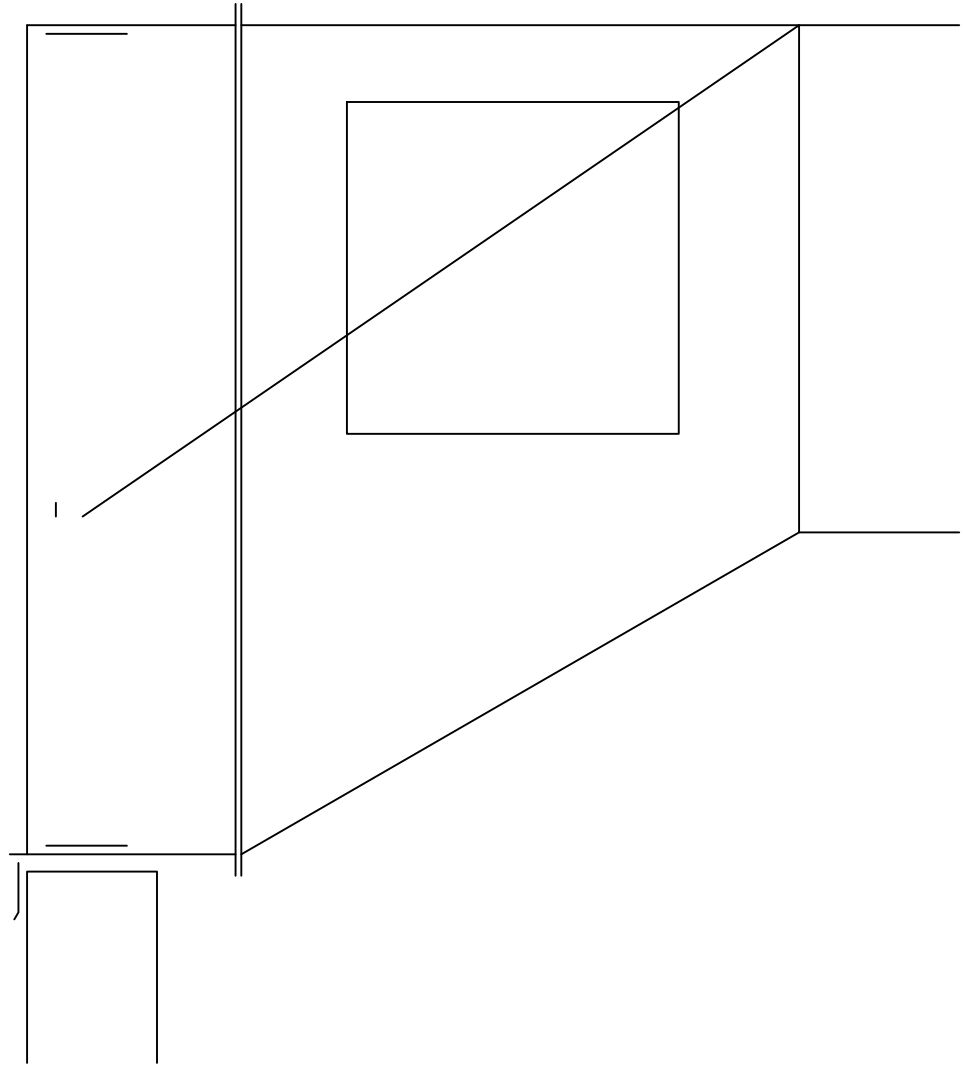
1. DO NOT ATTACH DUCT TO TOP OF LOWER LOUVER BLADE AS TYPICAL. THIS CREATES SEALING PROBLEMS AT MULLIONS AND OTHER VERTICAL MEMBERS.
2. CONSTRUCT SLEEVE AND DUCTWORK TO SUPPORT WEIGHT OF SERVICE TECHNICIAN.
3. SEAL JOINT BETWEEN DUCT AND SLEEVE WATER TIGHT ALL AROUND.
4. INSULATE DUCT AND SLEEVE AS SPECIFIED.
